## 2010 Doosan DX300LCA Crawled Excavator Service Repair Workshop Manual

# **DX300LCA**

Shop Manual

950106-00075E

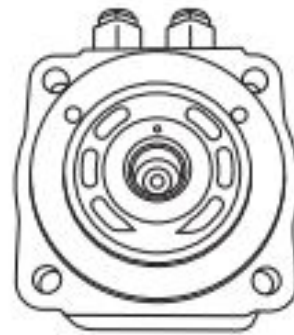
**Figure 86**

10. Position rear cover assembly on body (1) and tighten hex socket head bolt (23).

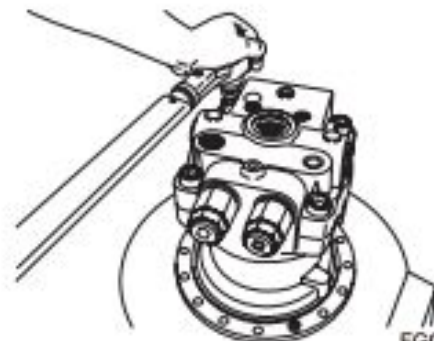
**Figure 88**

11. Install time delay valve assembly onto rear cover (19) with hex socket head bolts (35).
