# 2010 Doosan DX210/DX225LCB Crawled Excavator Service Repair Workshop Manual

# **DX210 DX225LCB**

Shop Manual

950106-00185E

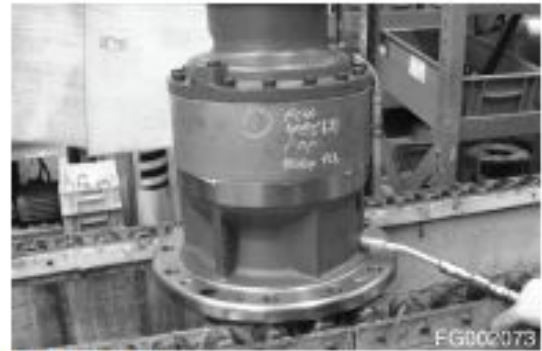
Figure 105

- Put the nipple to supply grease in the PT1/4 tap hole and start to supply grease until it flows out of the opposite PT1/4 hole.

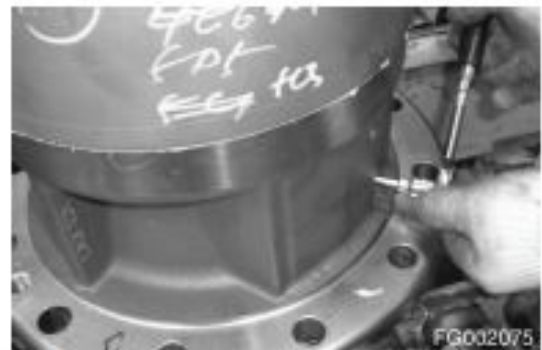
Figure 107

- After the completion of supplying grease, release and remove cokes, assemble the PT1/4 plug sealed with Teflon tape (torque: 220 kgf.cm), tighten it with a torque wrench, wipe out grease and other foreign substance remaining on the surface, and check the assembled position of the motor again.
